Spot Safety Project Evaluation

Spot Safety Project # 09-01-208

Spot Safety Project Evaluation of the Installation of High Intensity Signs, Guardrail Reflectors, and Additional Chevrons on the US 311 NB On-Ramp To I-40 Westbound in Forsyth County

Safety Evaluation Group
Traffic Safety Systems Management Section
Traffic Engineering and Safety Systems Branch
North Carolina Department of Transportation

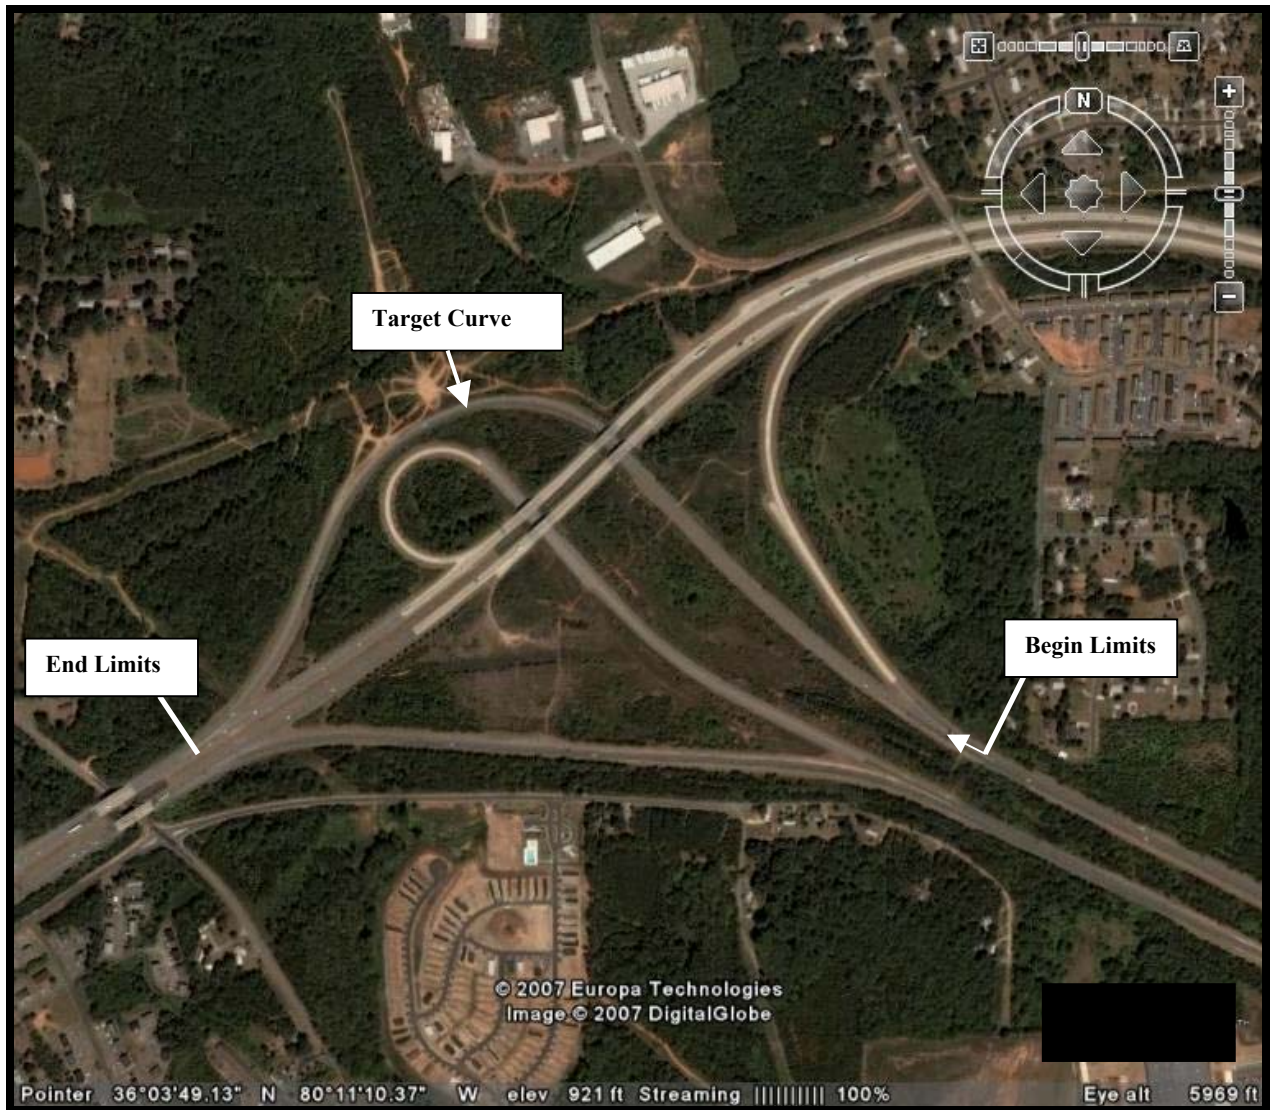
Treatment Site Photos Taken December 19, 2006

The spot safety project improvement countermeasures chosen for the subject location was the installation of high intensity signs, guardrail reflectors, and additional chevrons to warn drivers of the approaching curve. US 311 is a 4-lane divided highway that currently ends at I-40 from the south. In lieu of future construction, the two northbound lanes diverge left from a tangent section at I-40 along a loop ramp onto I-40 westbound. Curve warning signs with 45-mph advisory panels and flashers are located on both sides of the northbound lanes preceding the loop ramp from a speed limit of 65-mph on US 311.

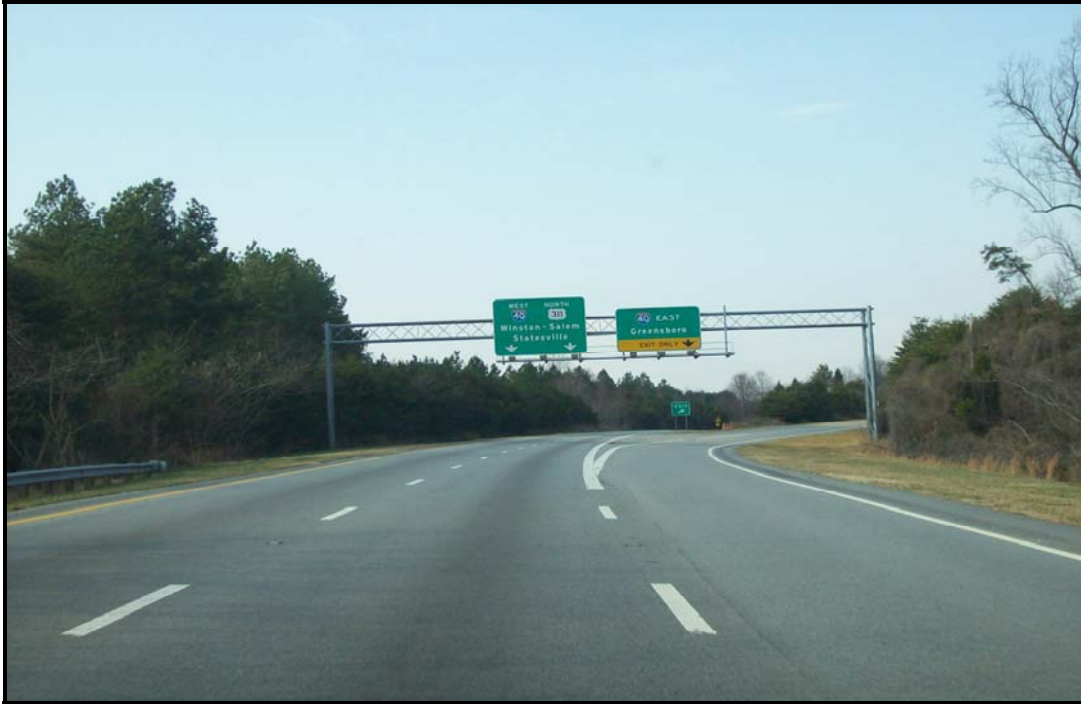
Start of US 311 Ramp to I-40 WB

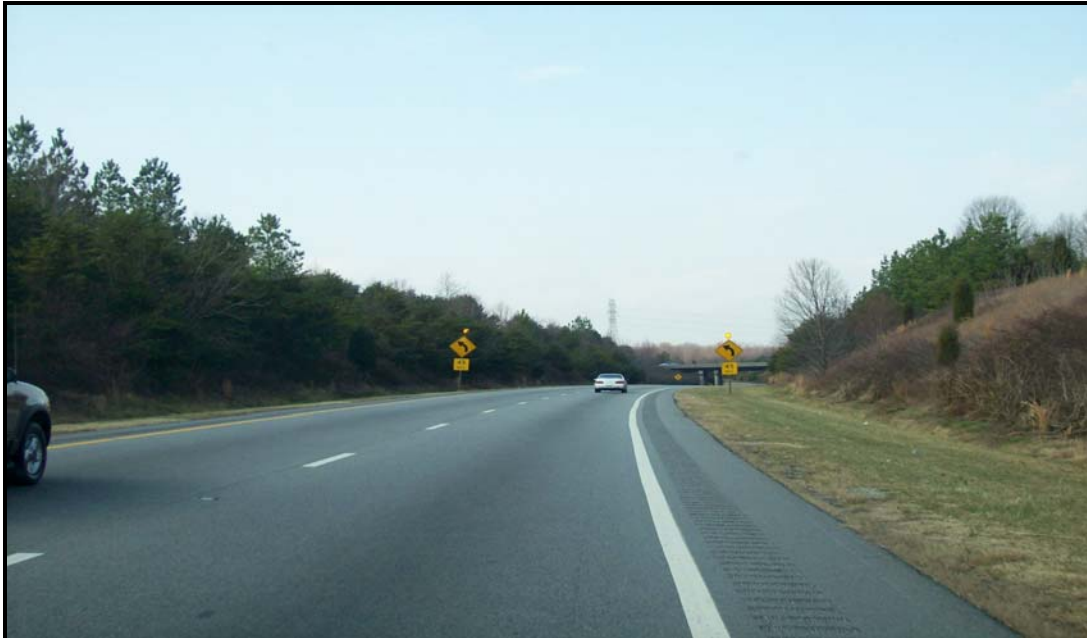
Curve Warning Signs with Flashers and 45 Advisory Speed

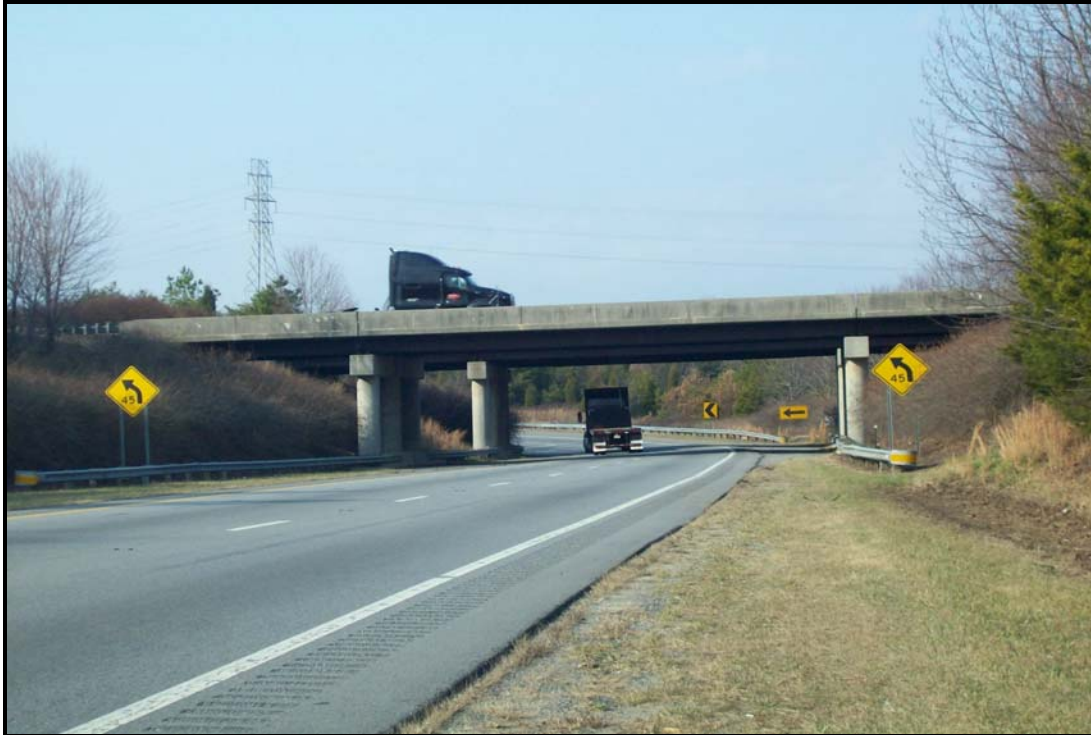
Curve Warning Signs and Chevrons

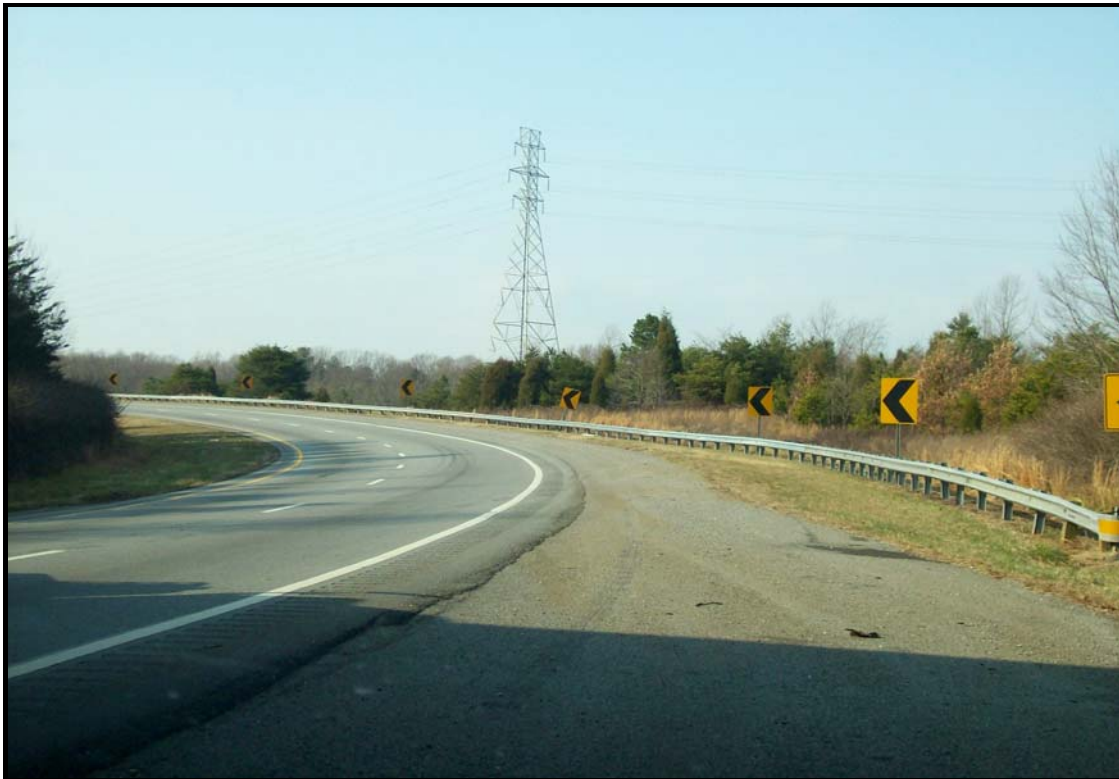
View of Curve with Guardrail and Chevrons

Referencing the *Collision Diagrams* and the previous tables, it appears that the countermeasure improvements made to attract the driver's attention to the curve were ineffective. The before period and after period *Collision Diagrams* show identical crash patterns to vehicles entering the left hand curve at a high rate of speed and losing control resulting in "Ran-Off Roadway" crashes with the

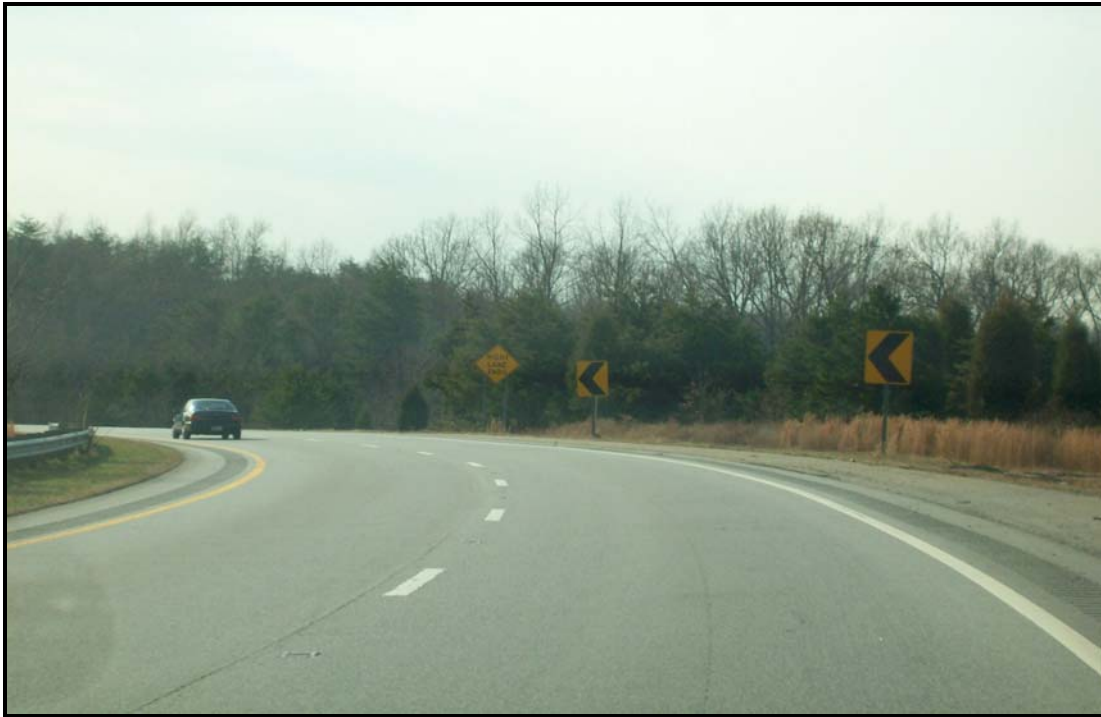
View from Middle of Subject Curve

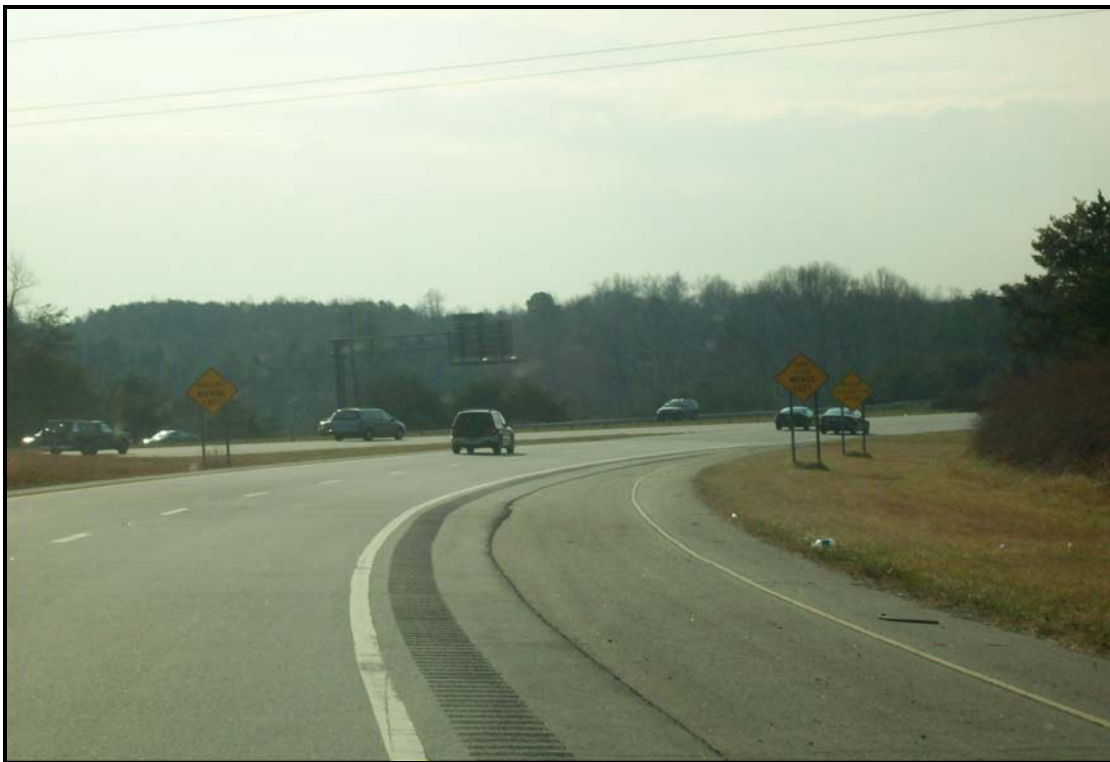
End of Curve / Junction with I-40 Westbound

guardrails. There was also an increase in the number of crashes at the ramp's junction with westbound I-40 during the after period. The additional crashes appear to be weather related including hydroplaning on standing water and sliding on ice.

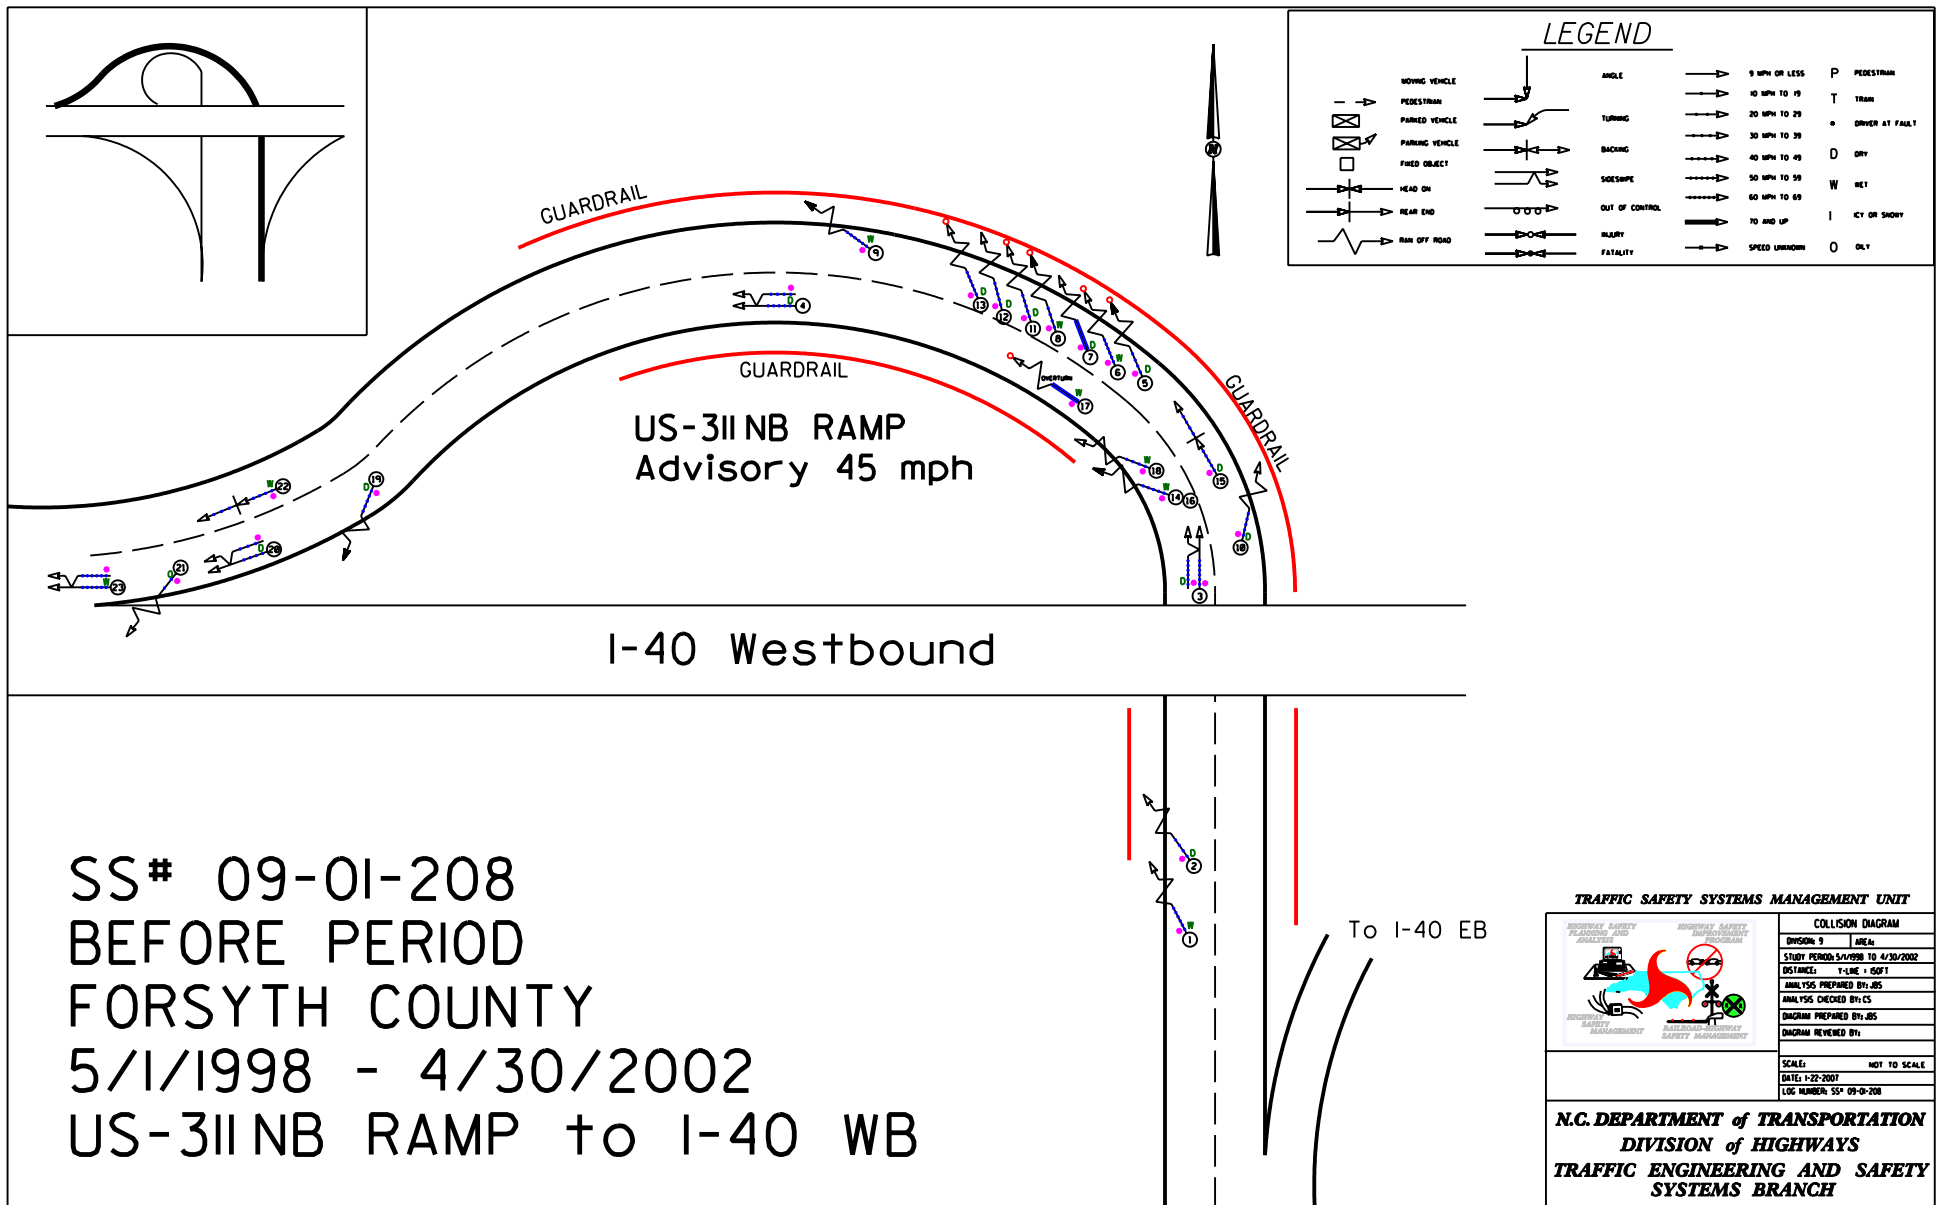
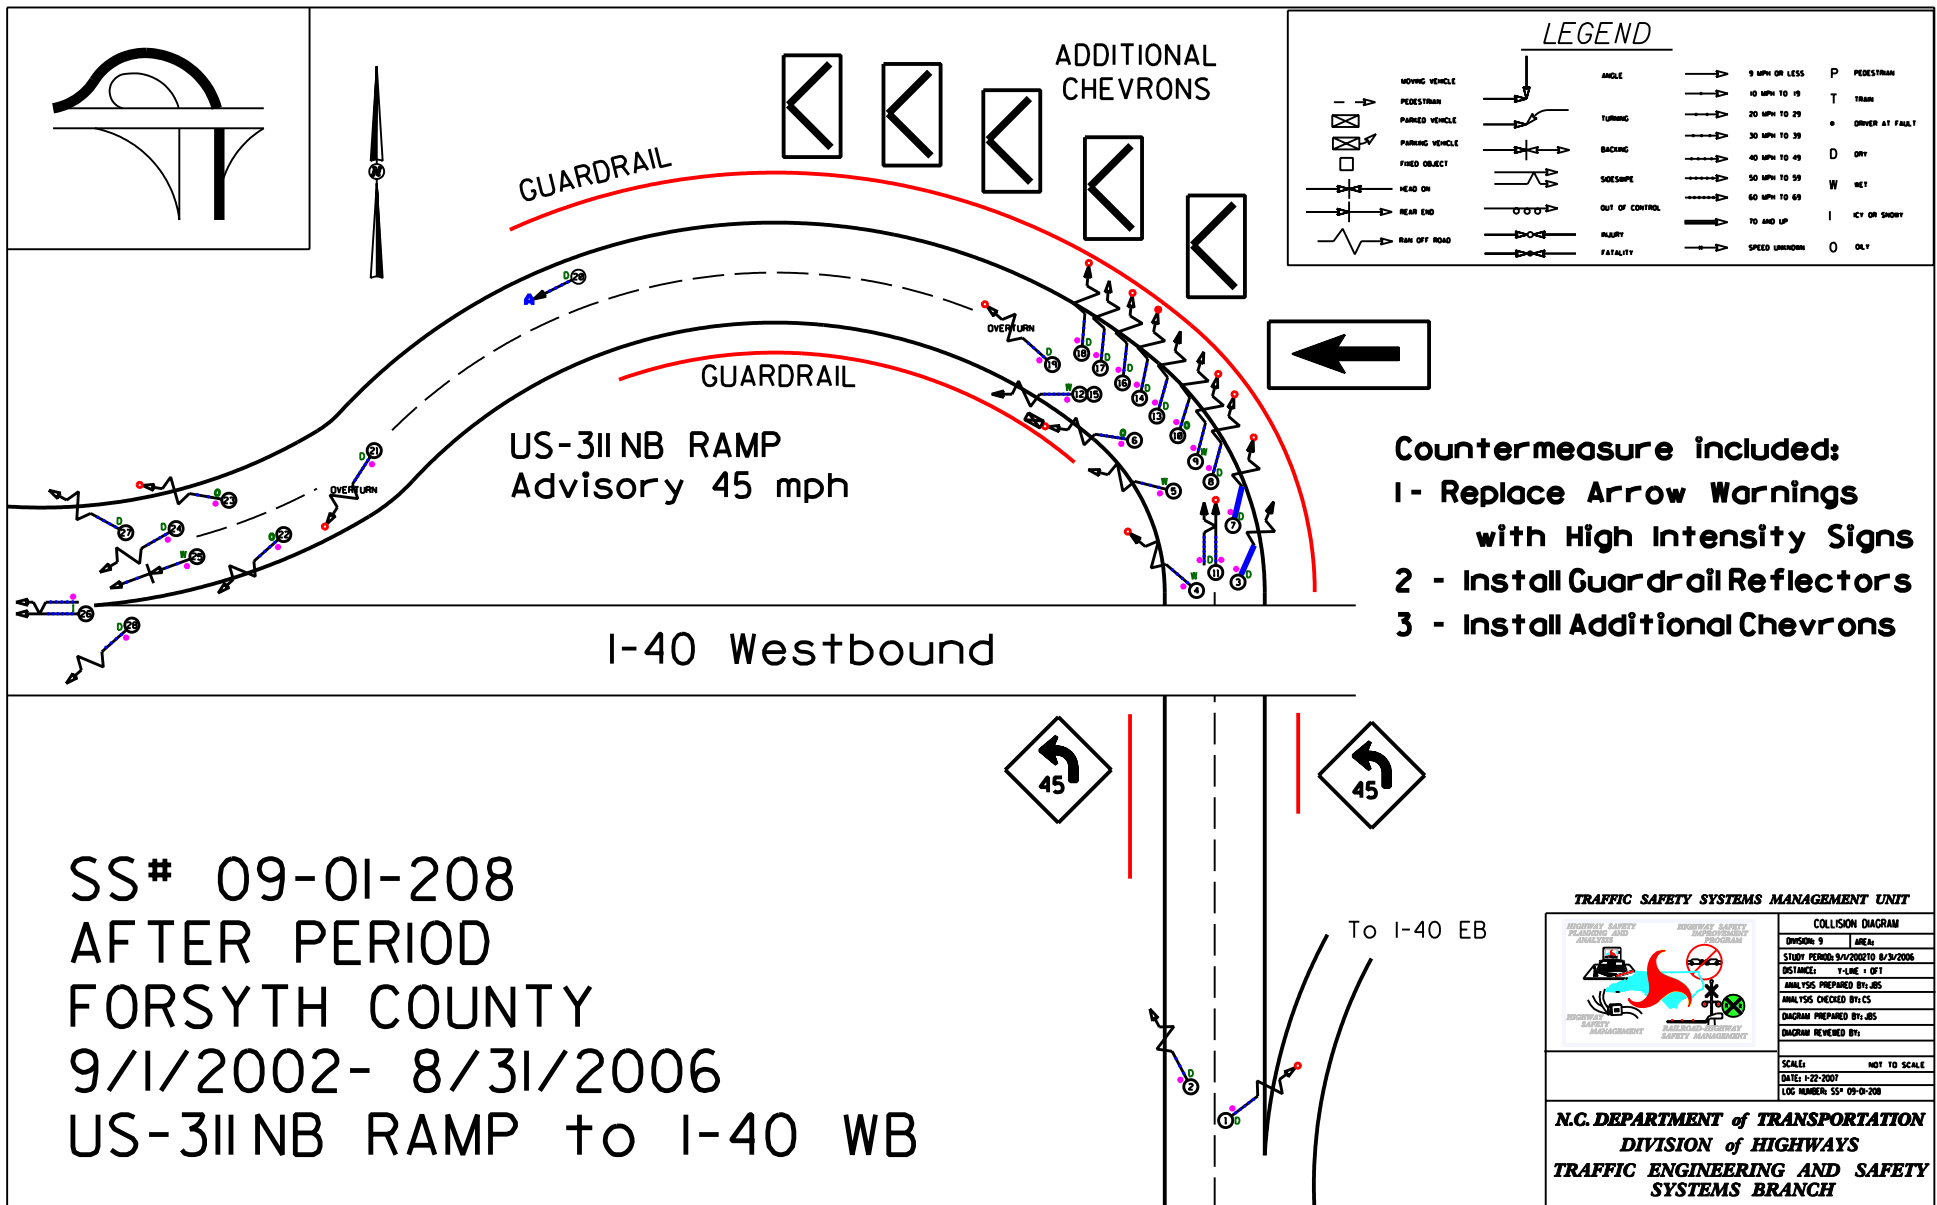
Again referencing the *Collision Diagrams* and the previous tables, speed continues to emerge as the rising issue. In the after period, 2 crashes occurred with impact speeds of over 80 mph. There were also 5 other crashes with impact speeds between 60 and 79 mph and two overturned tractor-trailer trucks that entered the curved ramp at an excessive speed.
